# **Review of slope deformations (landslides)** hazards in Southern Ethiopia

Petr Kycl Habtamu E, Debebe N., Ermias F.,Tutan, Daniel

CZECH GEOLOGICAL SURVEY

27.10.2014

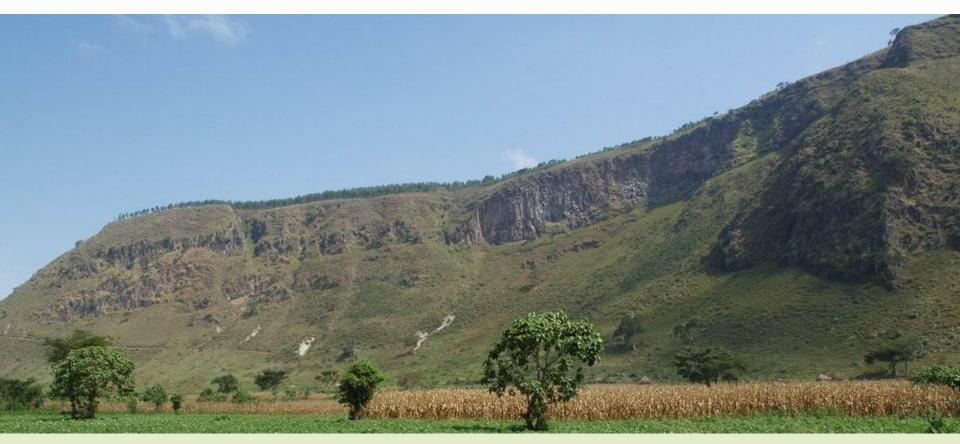
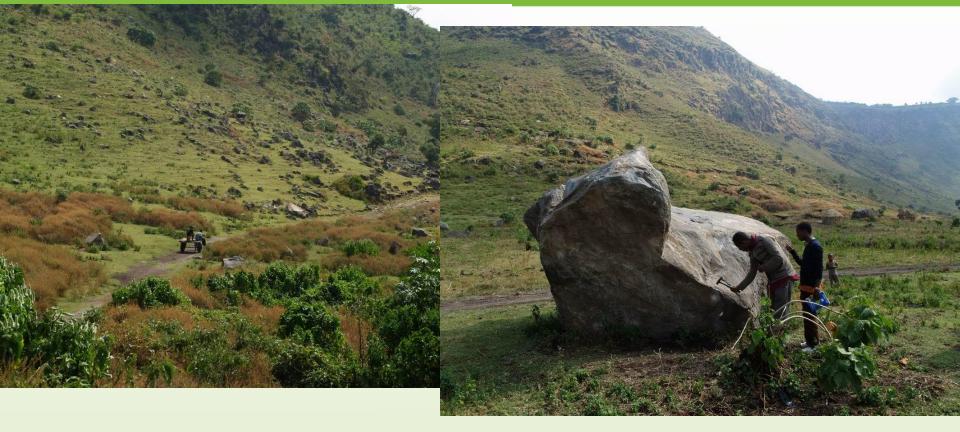
#### Area of occurence: Weransa Ridge - Caldera scarp south of Shashamene

The scarp is 100–300 m high and about 4 km long. The slopes are formed by rhyolite and blocky rhyolitic ignimbrite. Both lithologies are characterized by columnar jointing which predisposes the decomposition of the rocks and slope movement.

The thickness of old rock-fall deposits on the foothills could exceed 50 m. Blocks bigger than 3 m an volume about 30 m3.

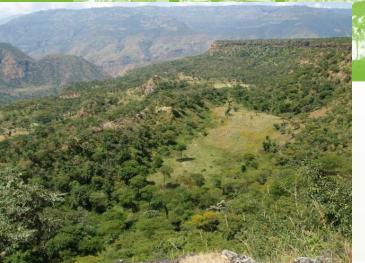
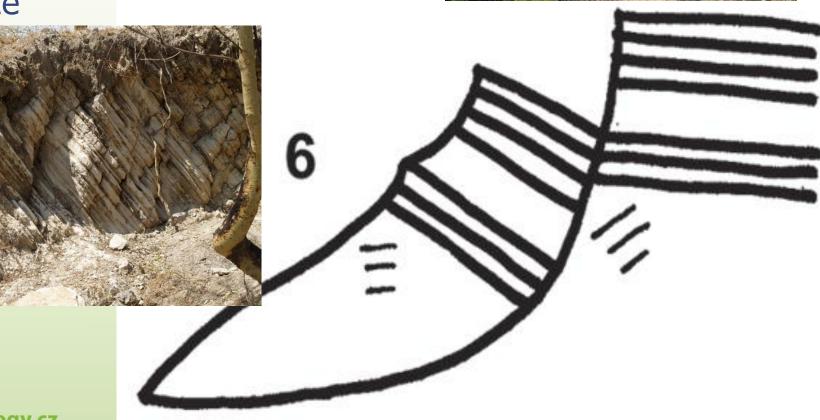
# Ameka Landslide – 3D wiev

Deep seated gravitational slope deformation **rock rotational slide** (rock compound slide) "Varnes update"

- documented dimensiones 4,5 x 2,5 km
- causes tectonic settings and erosion of Ameka River
- geology bazalt nad tufs in base covered by ignibrits ryolit, trachyt and tufs = sendvich structure
- vertical distance 450 mts
- damages still nothing, in case activity some tukuls
- slide blocks in dimension 900 m wide and 200 m long
- from main scarp waterfalls (Bischo falls, Ameka falls)

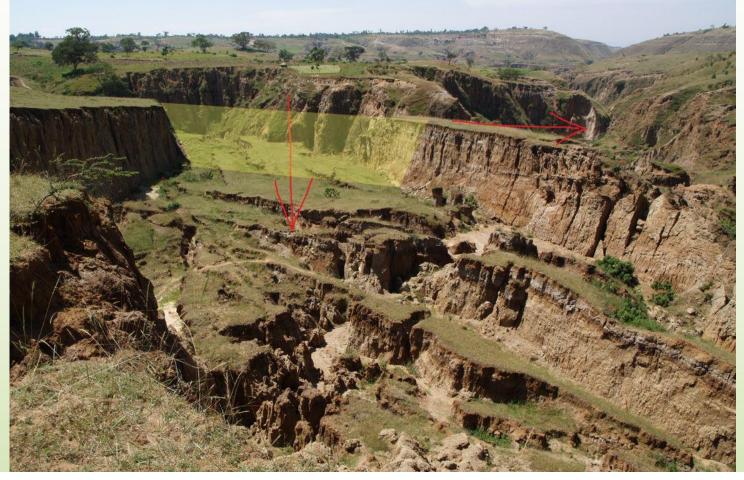
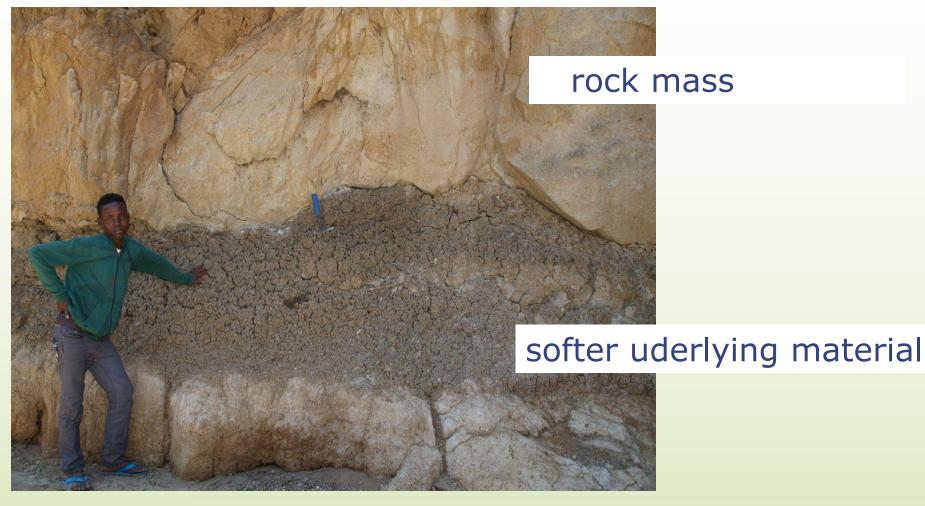
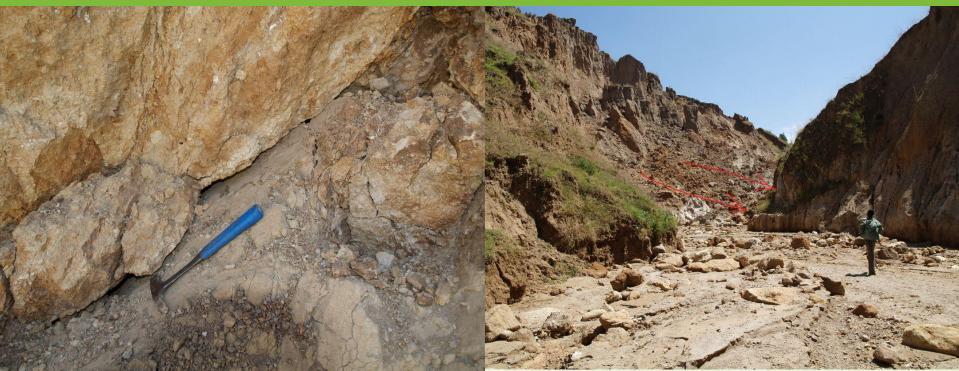
Approximately 2 km south of Belela village, 40 km southwest of Hawasa city, was located very impressive slope movement which can by described as "lateral spread"

# typical horst-and-graben features at the head with

The basal segment of the shear zone in this case follows a weak horizon of paleosoils www.geology.cz

• The area is extending to 300x 200 m and out of settlement.

• Many secondary shear surfaces, active, developing but no risky for infrastructure.

• The main scarp of lateral spread is more than 10 m high and outcrop shows low compacted ignimbrites which may be seen as soil.

• The masses of body pushed the stream channel, stream was temporarily damned and part of channel has created temporary lake.

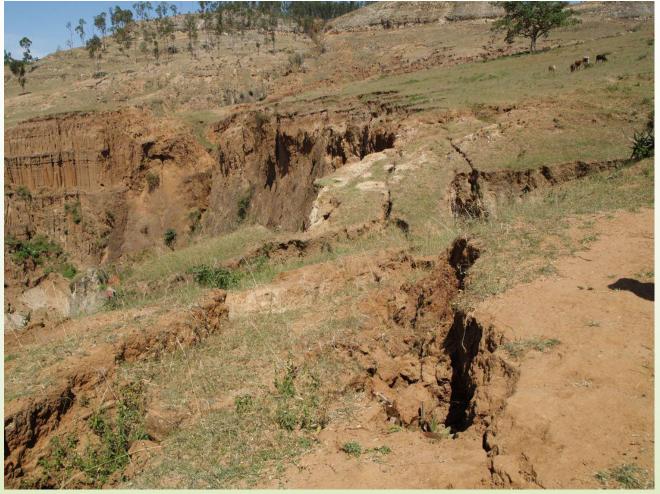
On surface in the foreground of movements we documented on November 2013 open cracks. On April 2014 was movements more extended. www.geology.cz

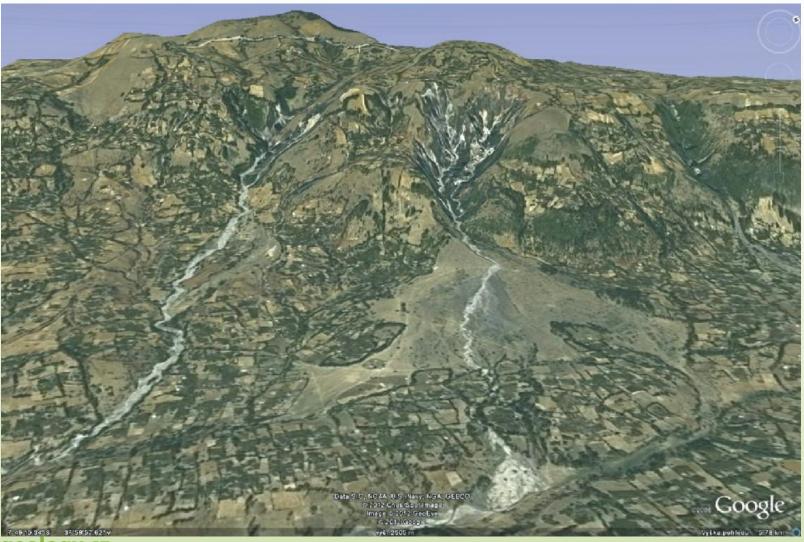
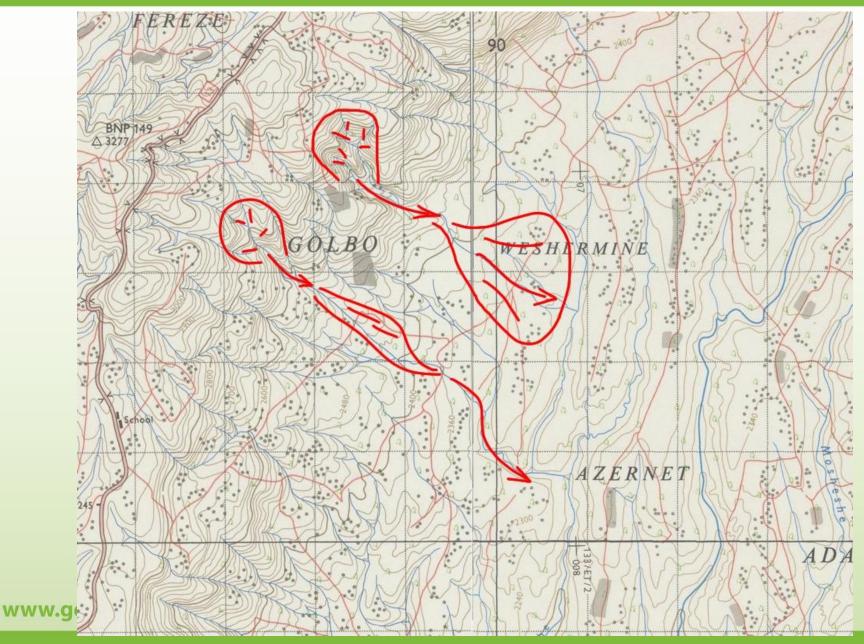
# Golbo Debris flow 1 and 2 – Google Earth

# **debris flow** exceptionally blocks of more than 10 m<sup>3</sup>

- documented dimensiones 3,6 x 1 km
- causes tectonic settings and weathering
- trigger heavy rains
- geology ignimbrits, highly weathered
- vertical distance 600 mts (2900 - 2300 m a.s.l.)
- damages ??? data from the locals not reliable
- dating unclear date of origin (probably repeatedly)
- difficult access for other measurement
