Landslide in motorway construction from Baku to Russia

Jan Novotný

Charles University in Prague, Faculty of Science, Czech Republic
ARCADIS CZ a.s., division Geotechnika, Czech Republic

Construction of motorway from Baku to Russia, landslide near village Devechi

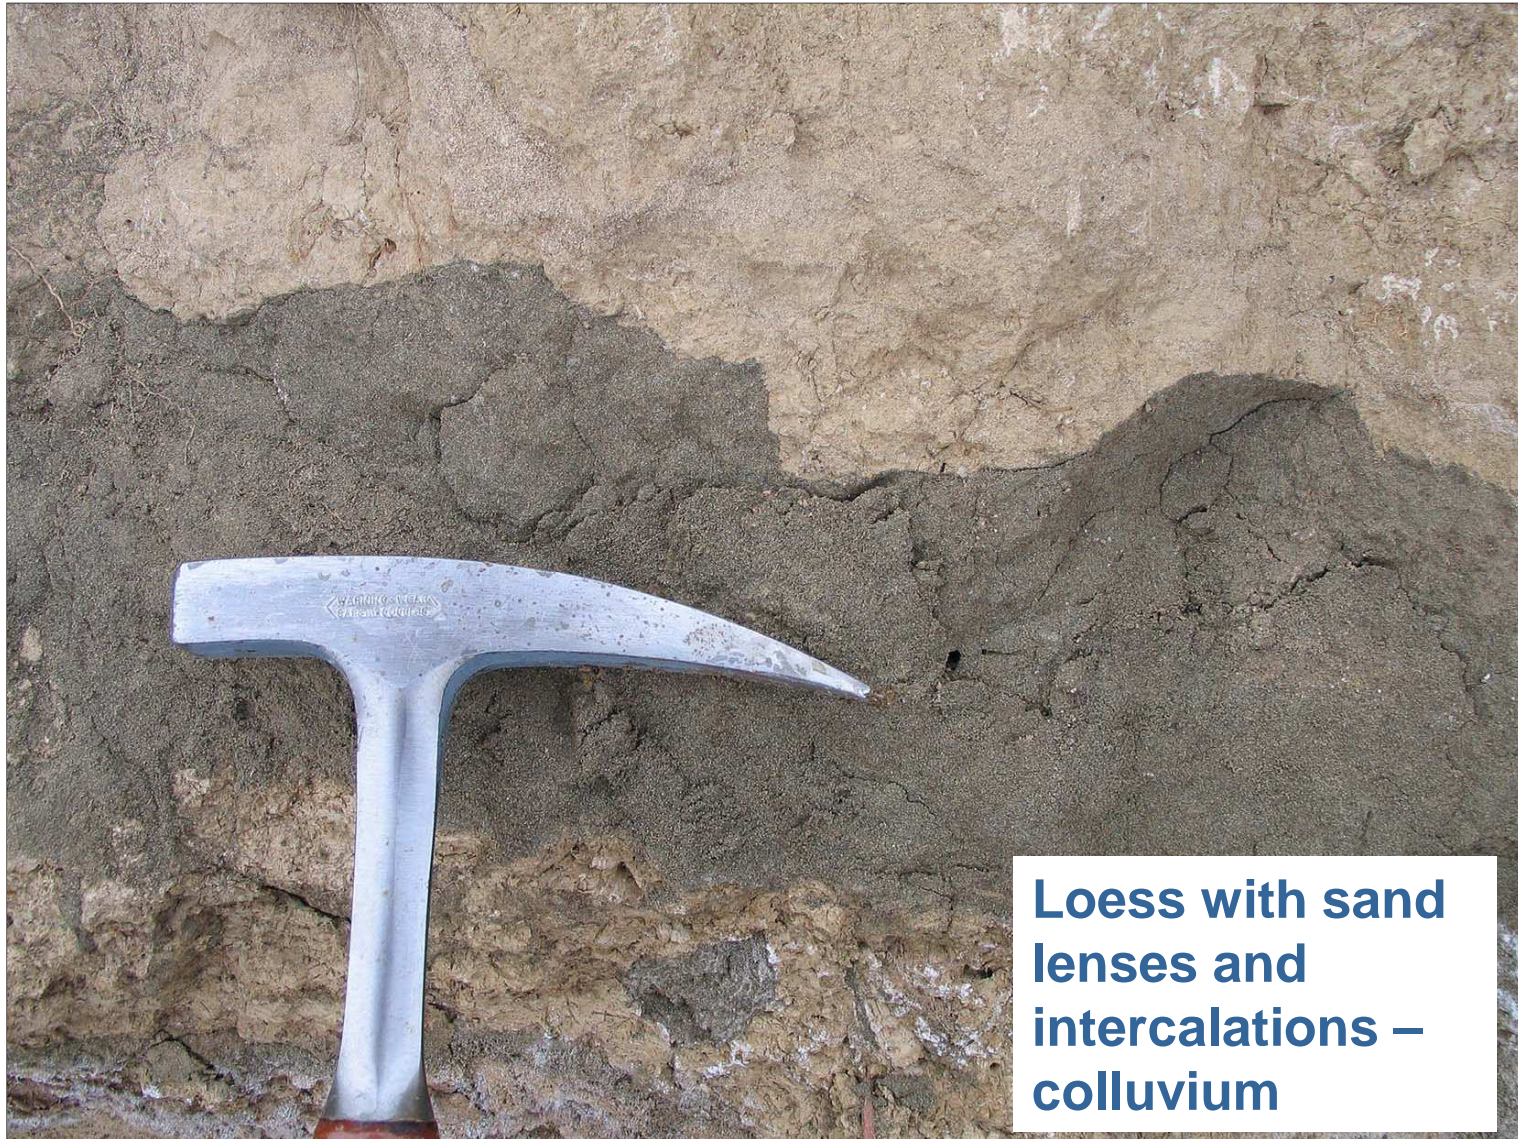
**Loess with sand
lenses and
intercalations –
colluvium**

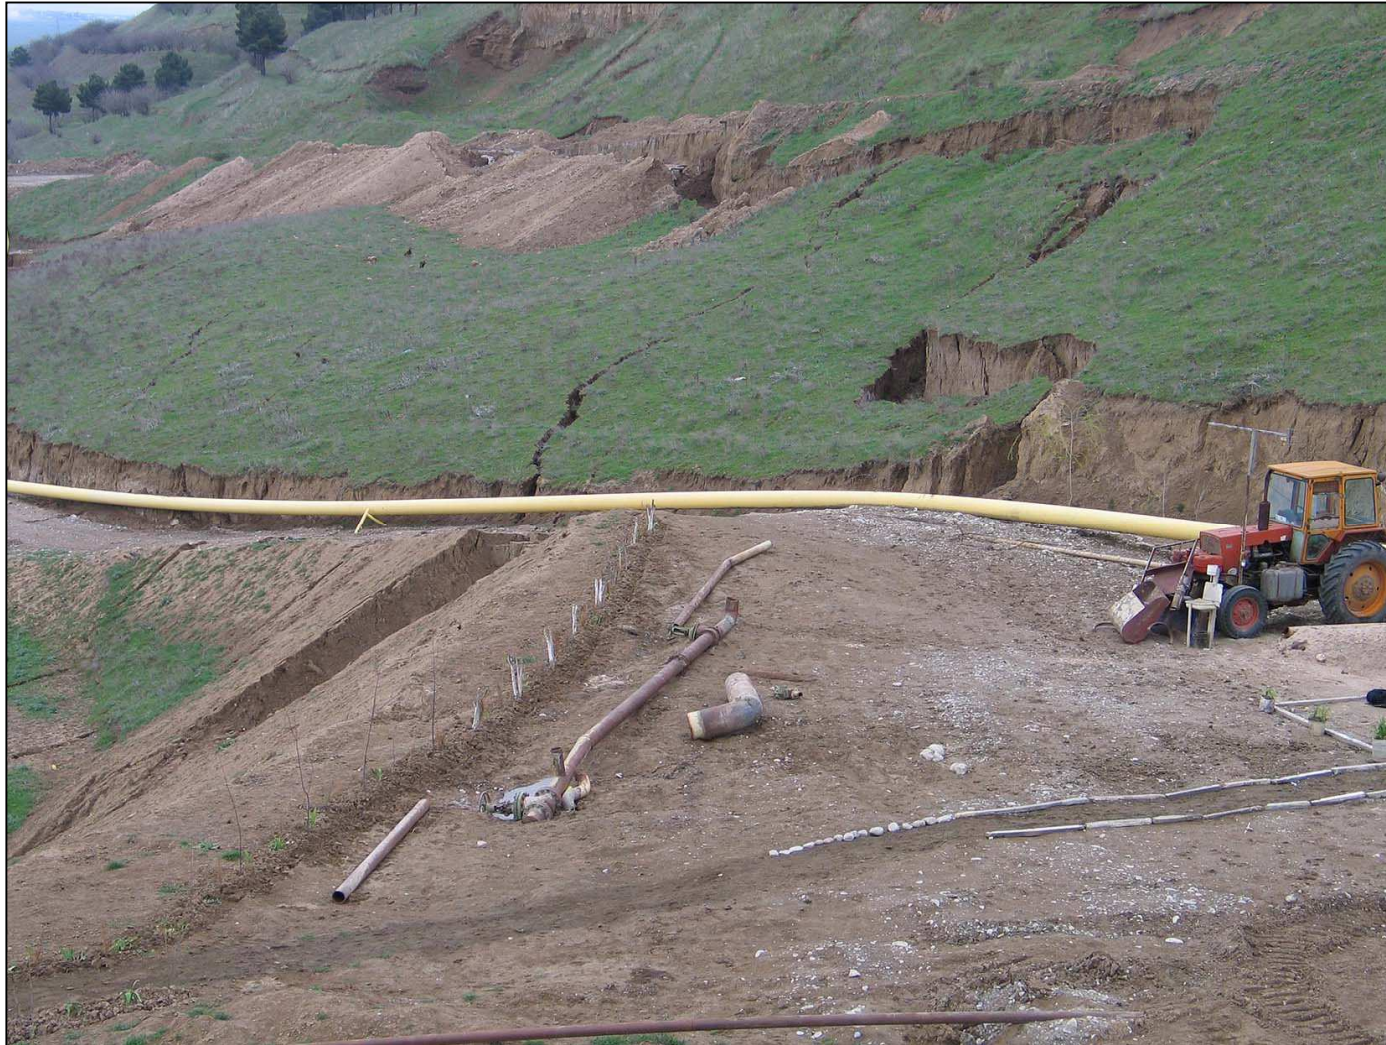
Azerbaijan, landslide in motorway construction from Baku to Russia
morphology of the landslide has to be taken account

No rotation, only tensile cracks – prevail displacements parallel to slope gradient

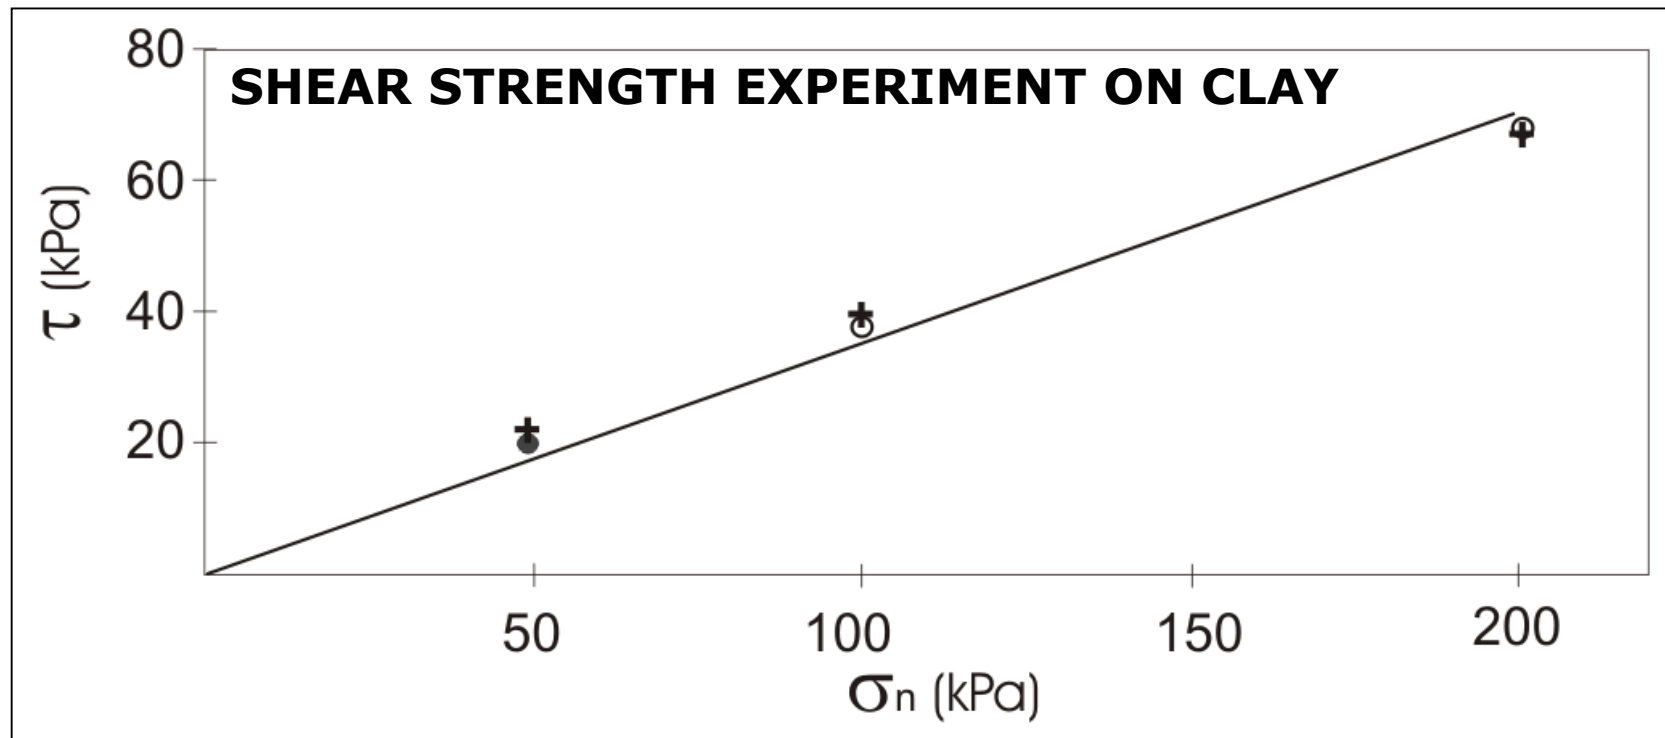
SHEAR STRENGTH EXPERIMENTS, CRITICAL STATE

$$\phi_{cr} (\text{CLAY}) = 20^\circ$$
$$(\text{LOES (SILT)}) = 30^\circ$$

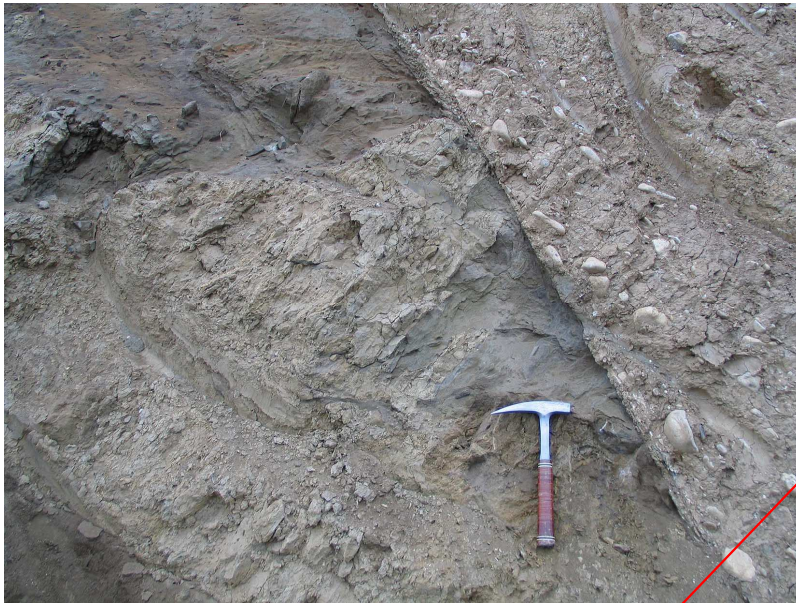
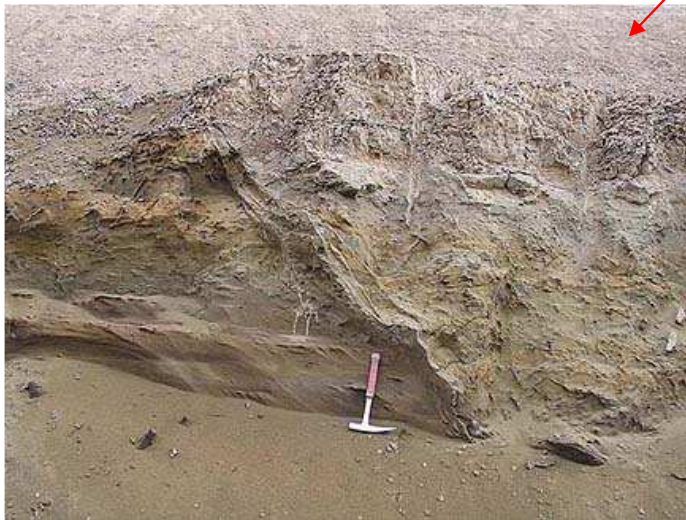
CONDITIONS OF LANDSLIDE ORIGIN

- Presence of clay layers pulled out from sands in parallel to slope inclination

- Tectonic distribution (even in colluvium)

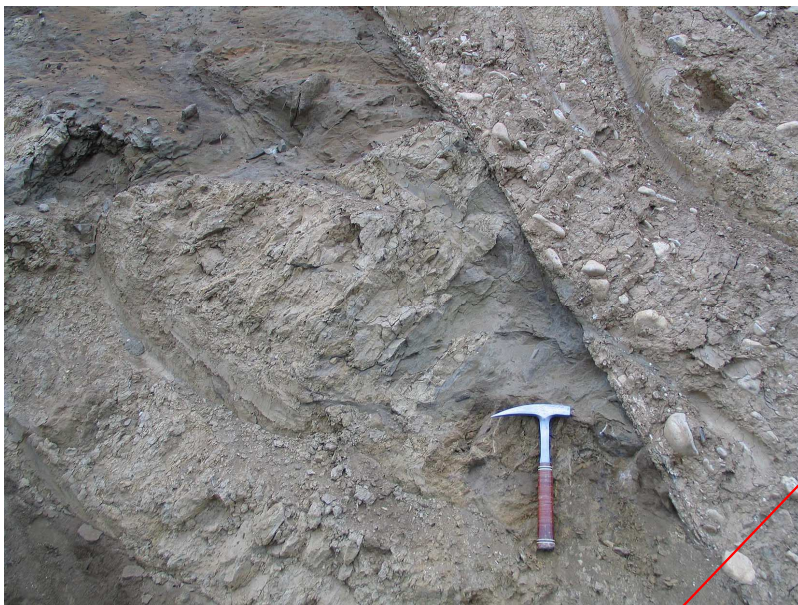
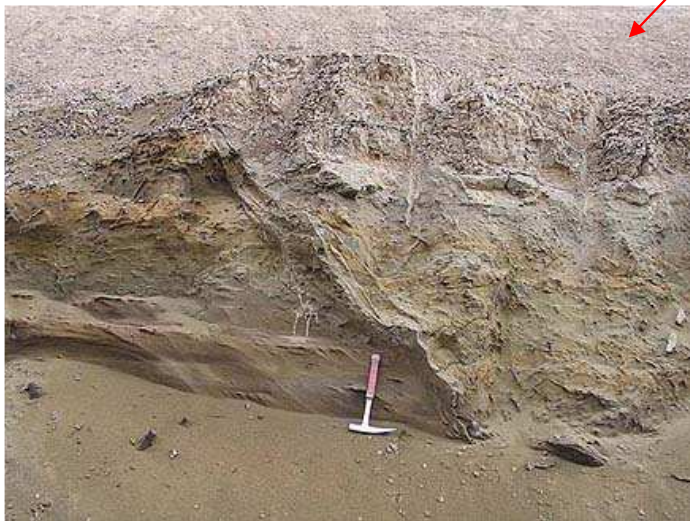
CONDITIONS OF LANDSLIDE ORIGIN

■ Presence of clay layers pulled out from sands in parallel to slope inclination

■ Tectonic distribution (even in colluvium)

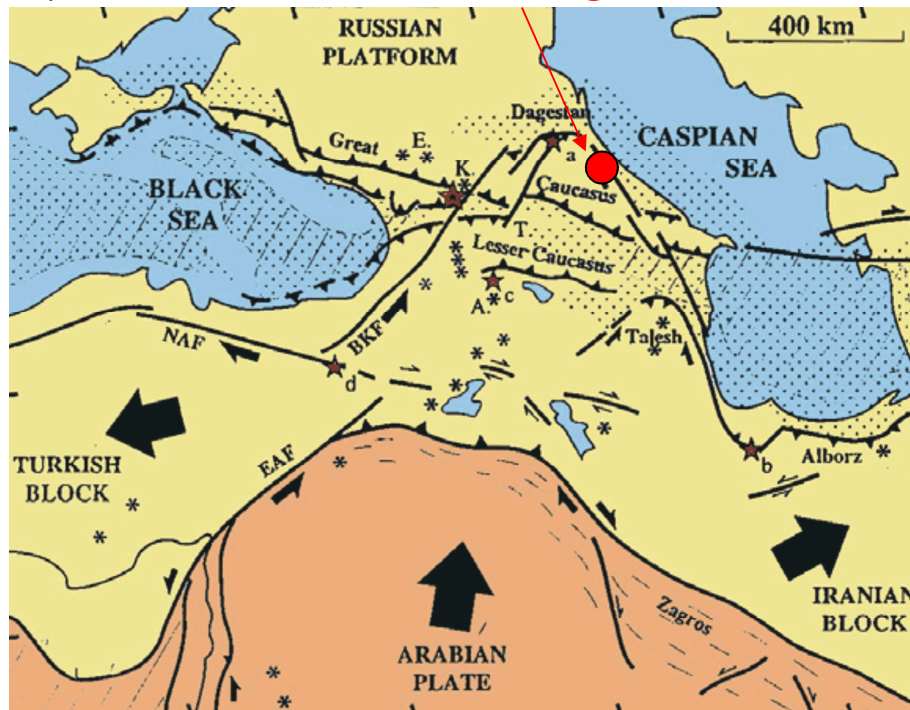
Schematic map of main tectonic features of the Caucasus and adjacent territories (after Philip et al., 1989). 1- active or Quaternary volcanoes; 2 relative motion of plates; 3 strike-slip faults; 4 thrust faults; 5 oceanic or intermediate crust; 6 - continental crust; 7 main sedimentary basin; 8 - recent folding at the border of Arabian Plate; 9 epicentres of major earthquakes.

TECTONIC SITUATION OF THE BROADER REGION
