# **Review of slope deformations (landslides)** hazards in Southern Ethiopia

Petr Kycl Habtamu E, Debebe N., Ermias F.,Tutan, Daniel

CZECH GEOLOGICAL SURVEY

27.10.2014

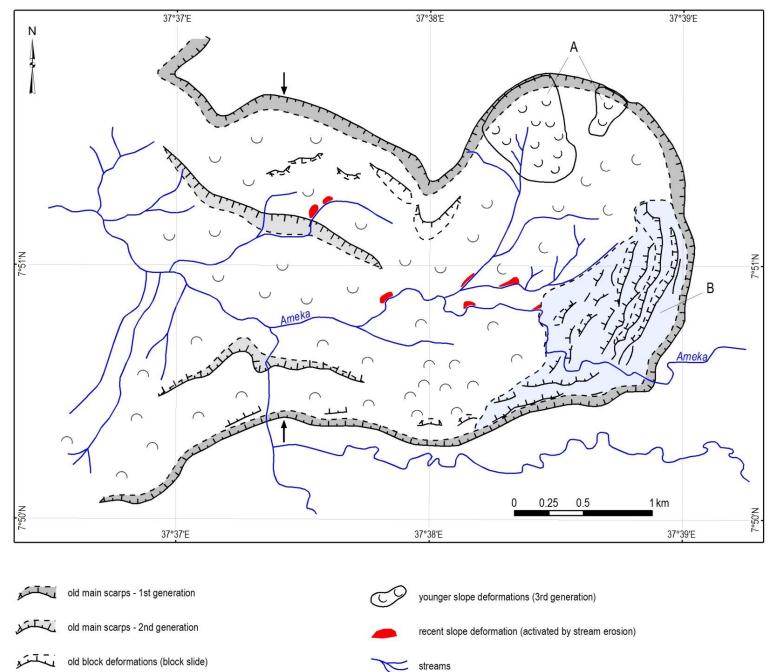
- documented dimensiones 4,5 x 2,5 km
- causes tectonic settings and erosion of Ameka River
- geology bazalt nad tufs in base covered by ignibrits ryolit, trachyt and tufs = sendvich structure
- vertical distance 450 mts
- damages still nothing, in case activity some tukuls
- slide blocks in dimension 900 m wide and 200 m long
- from main scarp waterfalls (Bischo falls, Ameka falls)

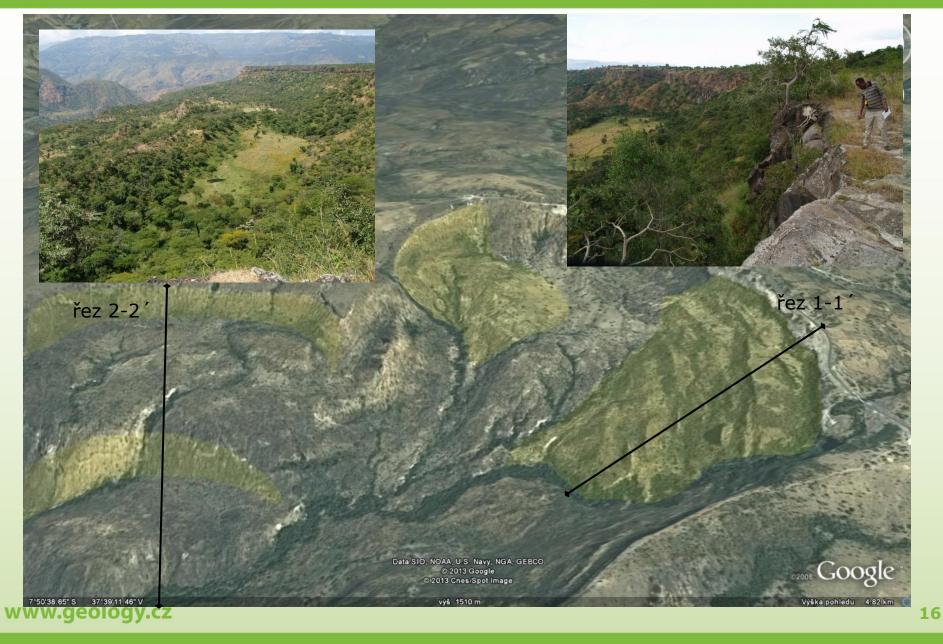
old landslide deformations - 1st and 2nd generation

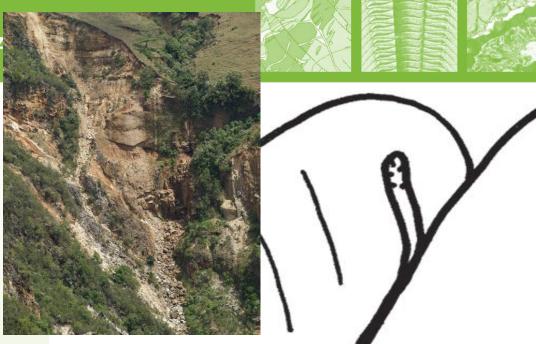
# **debris flow** exceptionally blocks of more than 10 m<sup>3</sup>

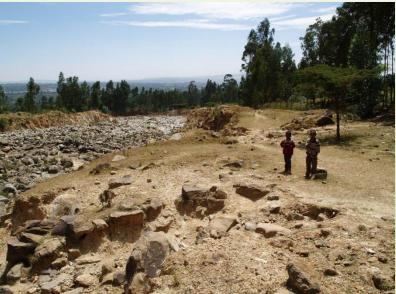
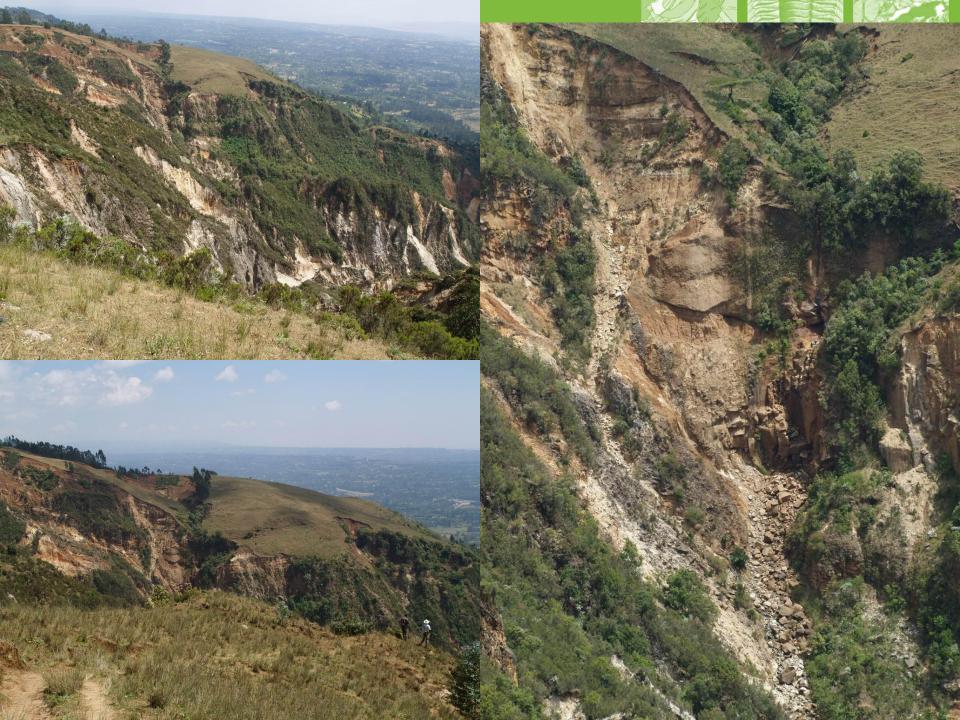
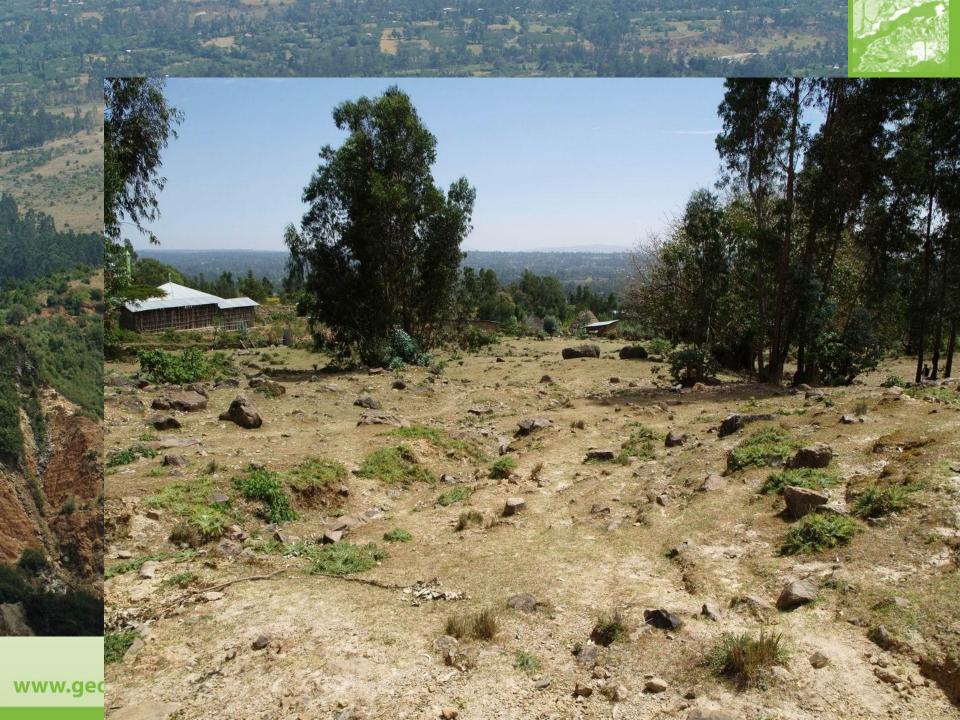
- documented dimensiones 3,6 x 1 km
- causes tectonic settings and weathering
- trigger heavy rains
- geology ignimbrits, highly weathered
- vertical distance 600 mts (2900 - 2300 m a.s.l.)
- damages ??? data from the locals not reliable
- dating unclear date of origin (probably repeatedly)
- difficult access for other measurement

- the whole area of main rift slopes is potentially susceptible to such phenomena (flows)
   = nessesary indicate as a risk zone
- flows high risk phenomenon
- is missing of land use planning for the construction
- restrict the construction of houses, tukuls, roads
- especially the foot of the slopes under erosion gully
